The use of nanosensors for monitoring civil structures

Mousaied Farhoud

Abstract

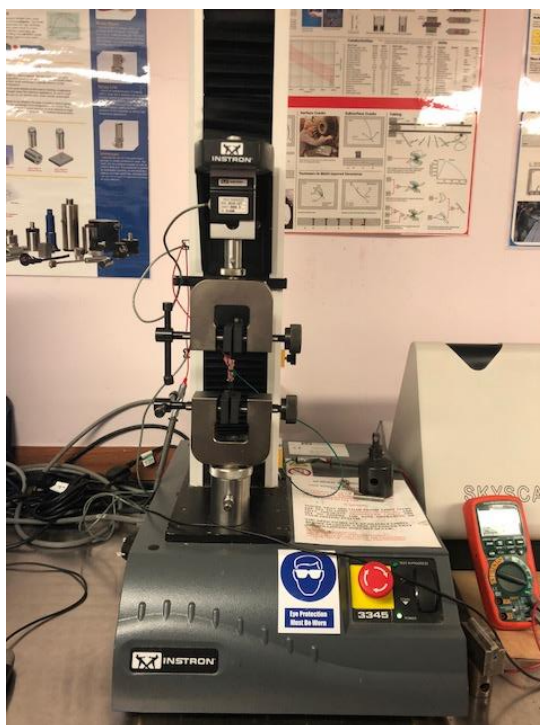
Figure 2: Instron 3345 used for tensile testing tube shaped sensors.

- Instron 5582 shown in Figure 1 was used to test the aluminium compact tension plate in tension.
- Multimeter was used to measure the resistance of the composite which increased with the application of tension
- Instron 3345 shown in Figure 2 was used to test the tube shaped nano-sensors in tension.

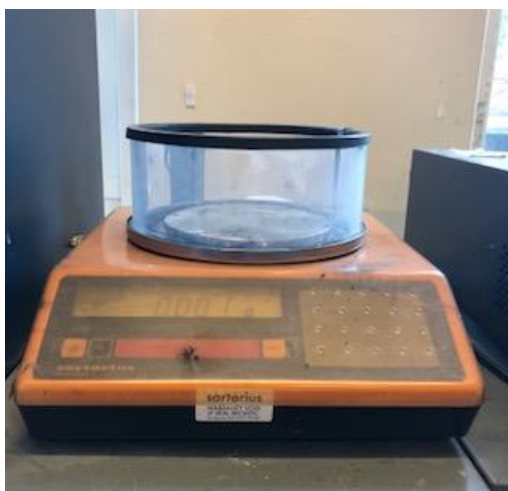
Figure 4: Sartorius scale for sample weight measuring.

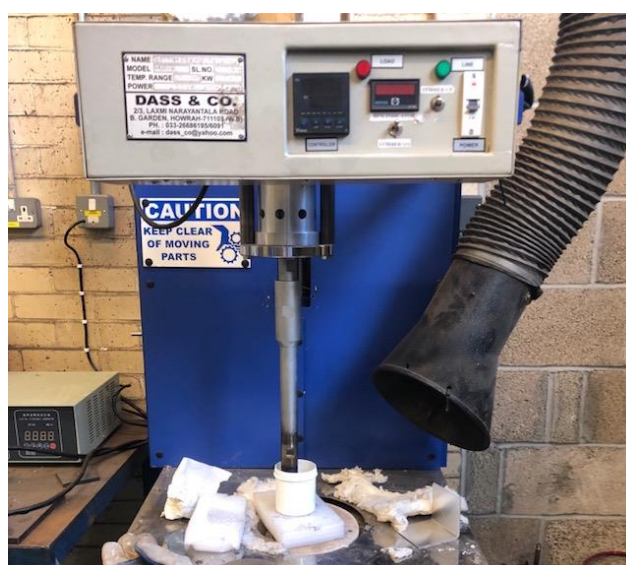
Due to the material's inability to disperse by regular mixing, a special machine was needed. The ultrasonicator was then used to disperse the CNT and PDMS. Additionally, Acetone was used to aid in the dispersion process. As shown in Figure 5, the ultrasonicator is a device, which uses ultrasonic sound waves to disperse nanoparticles in a solvent. The dispersion process was divided in to two rounds for all three containers. Each container took approximately 2 minutes a round while moving in circular motion to fully disperse the CNT in the solvent. Twenty extra grams of Acetone was then added to the material to get an improved mixture. The 20 grams of PDMS was then added to all three containers. The ultrasonicator was then used to disperse the composites in all containers once more. However, the ultrasonication process took about 5 minutes for each container to dissolve well in the second attempt. All three containers were then placed in an oven with a temperature of 60 degrees Celsius for 3 days to evaporate the acetone from the mixture. The mixtures were then ready to use after being checked if the Acetone fully evaporated out of the containers.

Figure 5: Ultrasonicator dispersing CNT/PDMS.

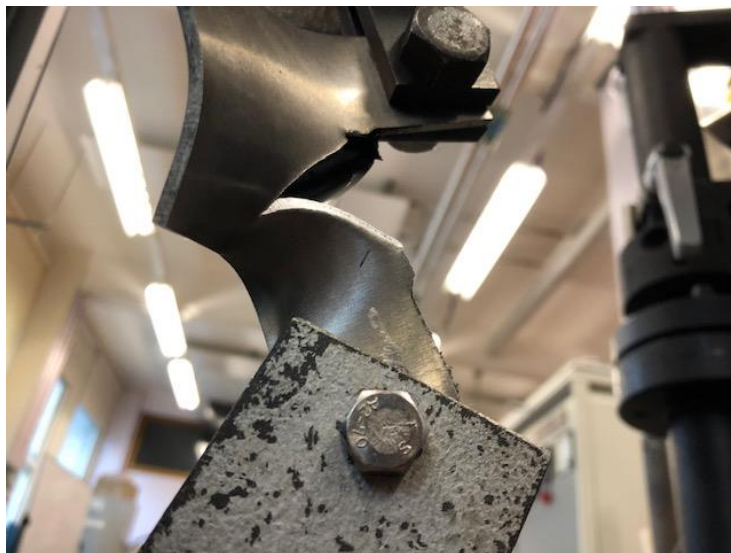
To test whether a more brittle material would improve the result, a quick test was conducted on a titanium compact tension specimen. Using the same equipment, tension was applied. Results demonstrated that a more brittle material showed improvement in the materials bending and crack path. A significant reduction in the specimens bending was observed. Additionally the crack had a straighter path with no great curve occurring.

Figure 14: Crack behaviour on the aluminium sample.
